BLM-Alaska Open File Report 64  
BLM/AK/ST-97/022+8111+040  
April 1997

# HISTORIC BUILDING SURVEY REPORT FLAT, ALASKA

by Rolfe G. Buzzell and Darrel L. Lewis

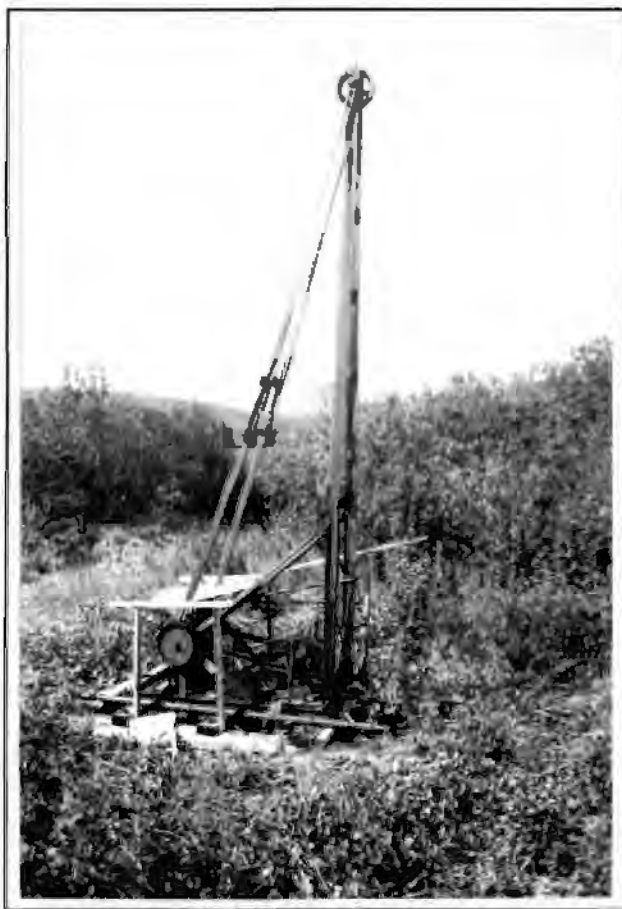
The NADC Drill Rig (IDT-116) is a wood frame drilling structure (Figure 67). The gantry is about 20' high. The base of the rectangular structure measures 5'8"x16' and the foundation consists of a pair of timber skids. A small shed roof covered with corrugated metal shelters the gears located inside the frame of the drill rig. The rig was manufactured by the Twin Disk Clutch Company. Drilling pipe is laying across the frame of the rig. Three large piles of 8" and 16" hydraulic pipe measuring 20' long are located about 30' northeast of the drill rig.

Figure 67. The NADC Drill Rig, 1993.  
The view is looking northwest.

The Drill Rig dates from the 1920s or 1930s. NADC crews used the drill to test mining claims for depth to bedrock and the amount of gold present. These tests determined which ground had enough gold to justify the expense of thawing and dredging (Miscovich 1995:III-35).

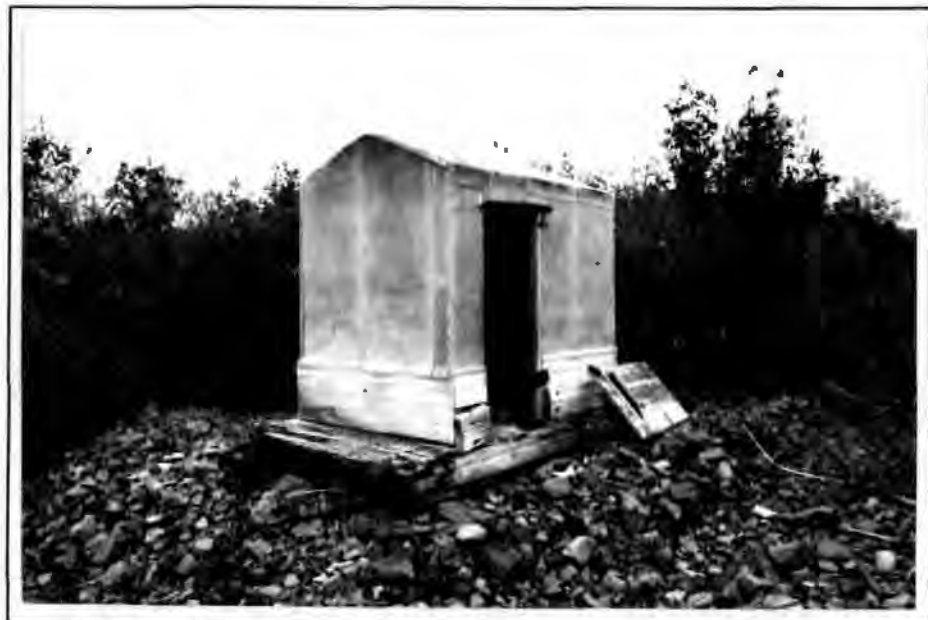
The **Shed on Skids (IDT-117)** is a rectangular, one-story, wood frame building on skids (Figure 68). The foundation consists of two 15'2" timber skids lined on the bottom with metal. A tow cable at each end of the sled runs through the end of the skids. Planks cover the skids, creating a floor for the sled. A rectangular, one-story, wood frame building rests on 4"x8" timbers running lengthwise along the floor. The enclosed building measures 5'6"x8'. The gable roof and exterior walls are covered with galvanized metal over shiplap. A 12" high band of shiplap is exposed along the base of the building. A doorway is located on the front (north) side. A plank door with one light is resting against the structure. A window opening without glass is located on both the south and west sides.

Figure 68. Sled on skids, 1993.  
The view is looking southwest.

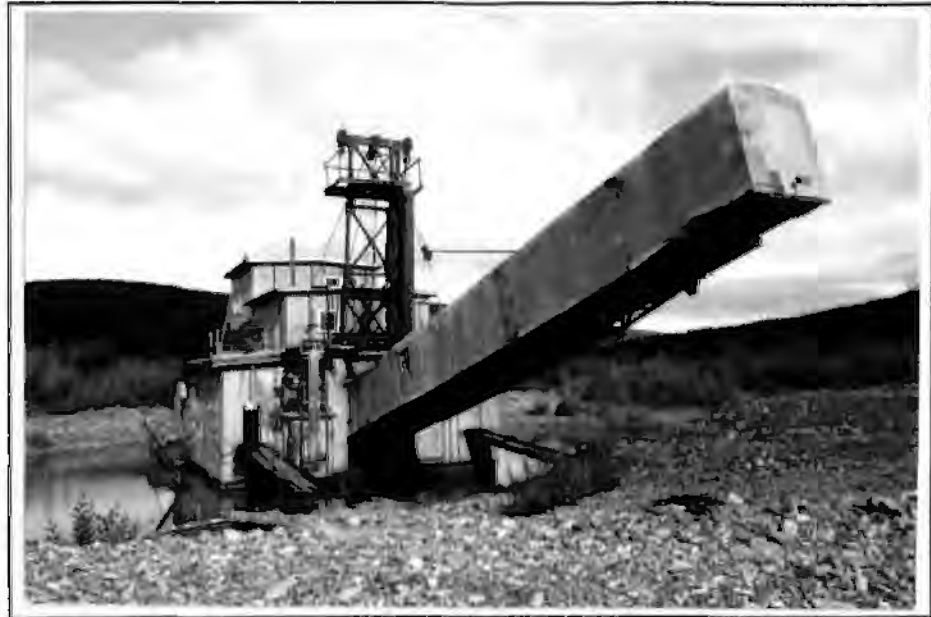
The **Matheson Dredge (IDT-118)** is a two-story, steel frame structure (Figure 70). The steel hull measures 39'x84' and rests on a shelf in a dredge pond. Galvanized metal covers the flat roof and exterior walls. The enclosed first floor structure measures 39'x57'. The second floor consists of a 20'x20'10" structure, a 20'x21'5" addition on the east end, and a 15'x16'2" addition (the bridge or control room) in the northwest corner. The gantry and the bucket line support structure are located on the west side of the dredge. A five-panel personnel door and an eight-light, fixed sash window are located on the first floor on each side of the gantry. A triple 1/1 single-hung window is located on the bridge on the second floor. The stacker, which is approximately 100' long and enclosed in galvanized metal, extends out the back or east end of the dredge. A five-panel door, a utility door, and an eight-light, fixed sash window are located on either side of the stacker on the first floor. Two four-light, fixed sash windows are

located on the second floor of the east elevation. The first floor of the north elevation has a large utility door, four 4/4 horizontal single-hung windows, and a 1/1 horizontal single-hung window. The second floor has a five-panel door and two 4/4 horizontal single-hung windows. The first floor of the south elevation has a five-panel personnel door, four 4/4 horizontal single-hung windows, and a 1/1 horizontal

Figure 70. The Matheson Dredge, 1993.  
The view is looking northwest.

single-hung window. The second floor has a five-panel personnel door, two 4/4 horizontal single-hung windows, and a pair of 4/4 horizontal single-hung window on the bridge. A three-cylinder gasoline engine located on the first floor of the dredge drives most of the machinery. The tumbler, crushing, stacking equipment, and the bridge are located on the second floor. The bucket line, which has been removed and is located about 100' west of the dredge, consists of 70 3.5 cubic foot buckets.

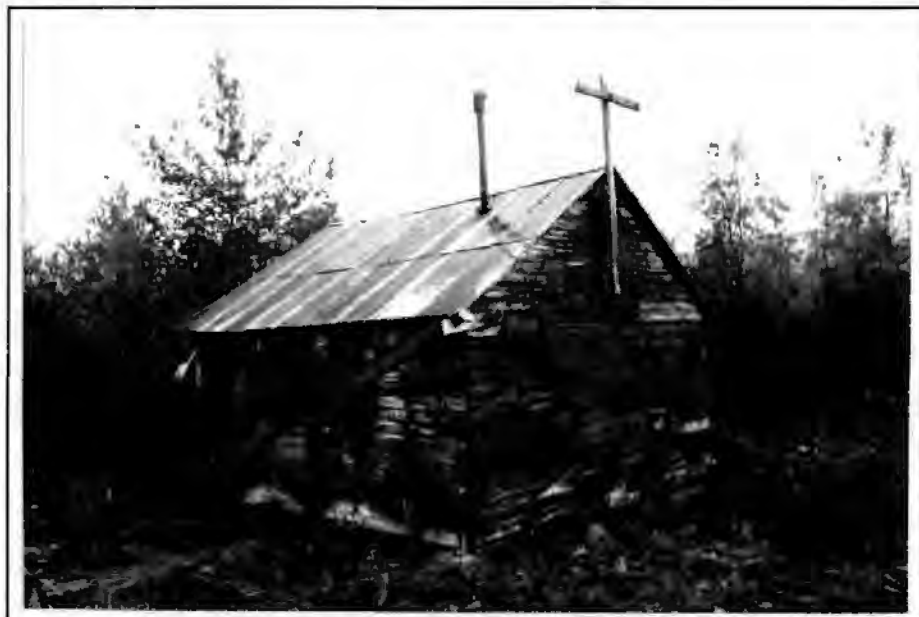
The **Jensen/NADC Pump House (IDT-119)** is a rectangular, one-story, wood frame building (Figure 71) located on the south bank of Otter Creek. The foundation consists of four 12"x12" skids. Corrugated metal covers the gable roof. The building measures 16'8"x 16'11", while the skid frame structure extends another 19' to the south. The exterior walls are covered with shiplap. The south elevation includes a five-panel door and a pair of single-light windows that are covered with corrugated metal. A six-light, fixed sash window is centered on the west elevation. The north elevation has a pair of boarded

**Figure 71. The NADC Pump House, 1993.**  
The view is looking northwest.

up single-light, fixed sash windows and a five-panel door. A boarded up two-light, fixed sash window is centered on the east elevation. A 12" metal water pipe extends from the east side of the building. A Washington Diesel engine is located in the center of the building. A large belt connects the engine to a drive shaft that turns the pump. A work bench is located along the south wall.

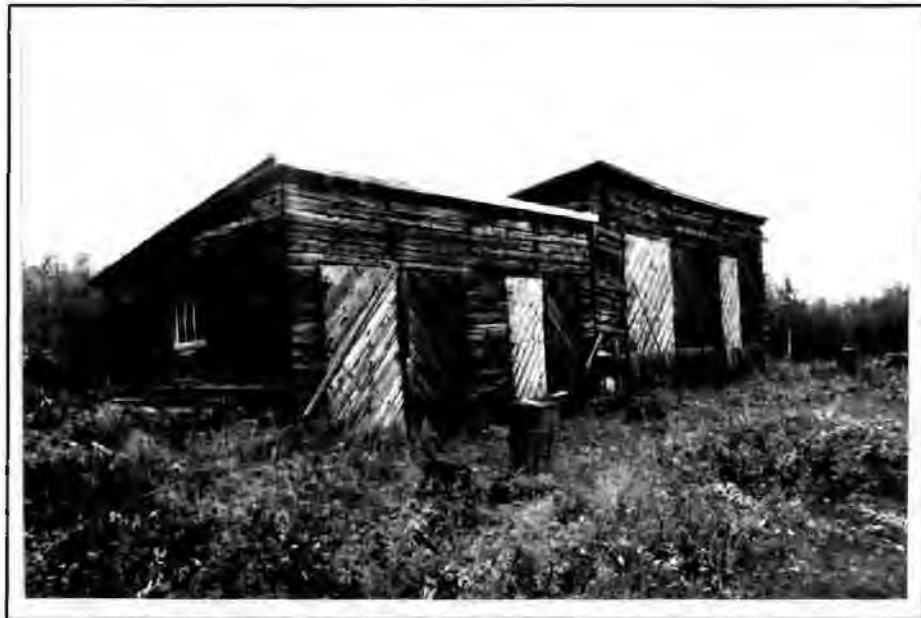
The **Turner/Hatten/Agoff Catsheds (IDT-120)** consists of two attached rectangular, one-story, wood frame buildings (Figure 72). Both buildings rest on wood blocks on grade and have shed roofs covered with corrugated metal. The first building measures 22'7"x31'4" and has exterior walls covered with shiplap. Two pairs of side-opening utility doors are evenly spaced

on the south elevation of the building. The east elevation contains a six-light, fixed sash window and a plank door with a two-light, fixed sash transom window. Two six-light, fixed sash windows are located on the north elevation. The second building is joined to the west side of the first structure, which is taller. A space of 2'2" separates the buildings. The two buildings are connected on the south elevation (main entry) by an exterior wall. On the north side, a small utility door connects the two buildings. A vertical plank door connects the first building with a five-panel door in the second building. The second building measures 18'1"x24'4" and the exterior is covered with shiplap. Two pairs of side opening utility doors are evenly spaced on the south elevation. A six-light, fixed sash window is centered on the west and north elevations.

**Figure 72. The Turner/Hatten/Agoff Catsheds, 1993. The view is looking northeast.**

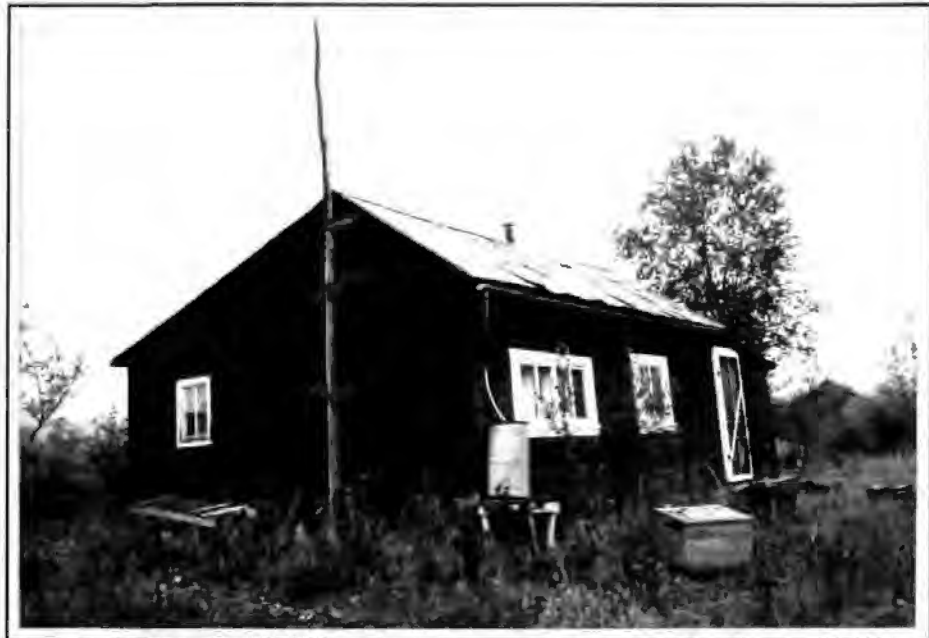
The Sagoff/Demientieff/Wintz House (IDT-121) is a rectangular, one-story, wood frame building (Figure 73). The foundation is hidden by corrugated metal skirting. The gable roof is covered with corrugated metal. The house measures 12'3" x 19'11" and the exterior is sided with shiplap. The south elevation has a pair of two-light, fixed sash windows and a separate two-light, fixed sash window. The east elevation has a two-light, fixed sash window and a small shed roof arctic entry. The arctic entry has a five-panel door facing south and a single-light, fixed sash window facing east. A shed roof addition on the north elevation joins the gable roof at the apex. The addition measures 12' x 19'11" and wood siding covers the exterior. The east elevation of the addition has a pair of single-light, fixed sash windows. The north elevation has two single-light, fixed sash windows and the west elevation has a four-light, fixed sash window.

Figure 73. The Sagoff/Demientieff/Wintz House, 1993. The view is looking northeast.

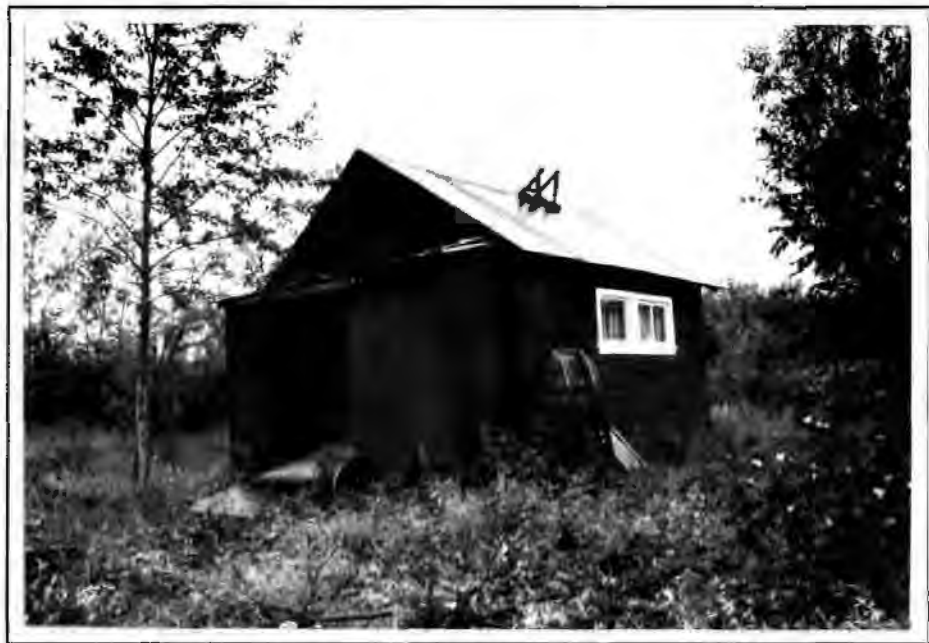
A rectangular, one-story, wood frame workshop building (Figure 74) is located 52'6" east of the wood shed. The foundation is not visible. Roofing felt covers the gable roof. The building measures 16'1"x18'1" and the exterior is covered with wood siding. The main entry is the north elevation, which has a pair of side opening doors covered with celotex. The north elevation is covered by an enclosed porch.

**Figure 74. Dave Wintz's Workshop, 1993.**  
The view is looking southeast.

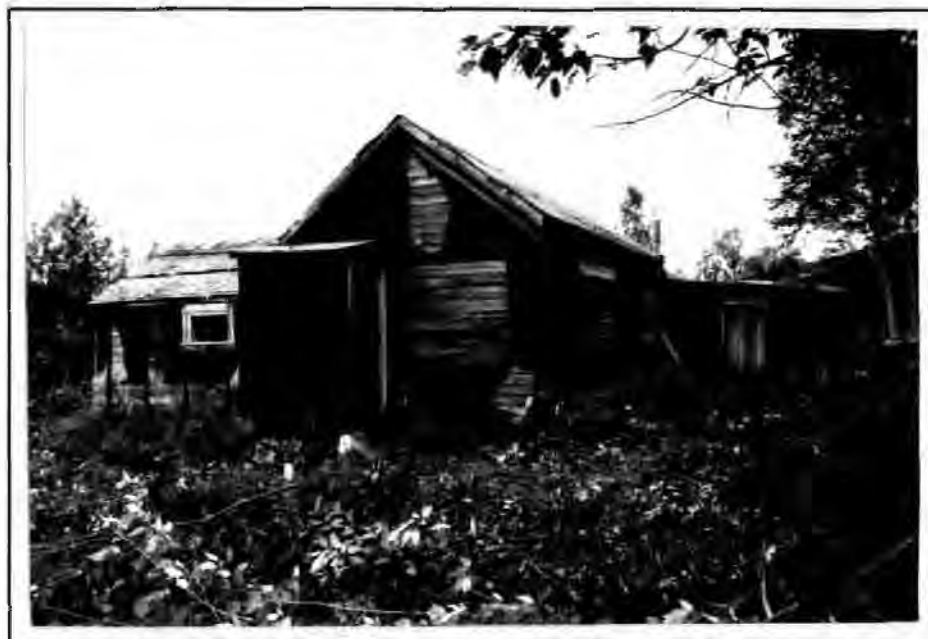
The **Fullerton/Durand/Roper/Byrd House (IDT-133)** is an "L" shaped, one-story, wood frame building (Figure 76). The foundation consists of logs on a raised rock pad. Wood shingles cover the gable roof. The house measures 12'2"x22'9". The exterior walls are covered with roofing felt over wood shingles. The main entry is on the east elevation, which contains a boarded up four-light, fixed sash window and a shed roof arctic entry measuring 4'2"x5'2". A four-panel door with one light is located on the north elevation of the arctic entry. The north elevation has two boarded up windows. The south elevation has a boarded up window and a gable roof addition extending south from the main portion of the building. The addition measures 12'2"x14'3" and has a boarded up window centered on the south elevation. A single-light, fixed sash window on the east elevation. This addition gives the house an "L" shape.

A gable roof addition measuring 10'6"x12'2" is located at the west or back side of the house. A boarded up window faces west and a two-light, fixed sash window faces south. A shed roof addition measuring 11'5"x14'8" is located on the north side of house. The shed roof and exterior walls are covered with corrugated metal. A two-light, fixed sash window faces east and a boarded up window faces north. An entry

**Figure 76. The Fullerton/Durand/Roper/Byrd House, 1993. The view is looking southwest.**

on the west elevation has no door. A shed roof arctic entry measuring 3'4"x3'11" is located on the west end of the south side of this addition. The arctic entry abuts the west side of the west gable addition. The south elevation of this arctic entry has a five-panel door.

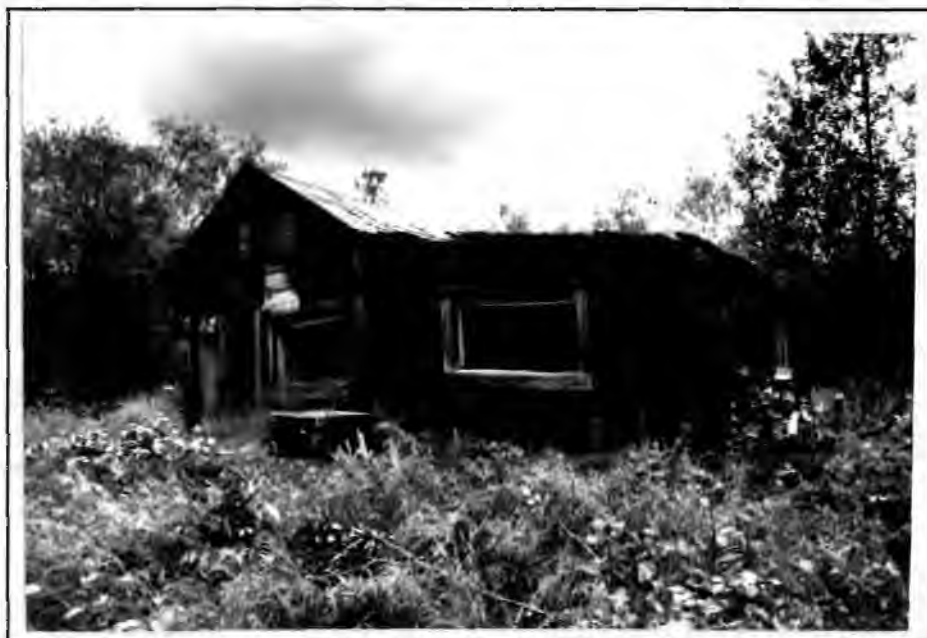
**The Remington/Duffy/Baquir House (IDT-134)** is a rectangular, one-story, wood frame building partially in ruins (Figure 77). The foundation is timbers on grade. The gable roof is

covered with corrugated metal over wood decking. The main part of the building measures 12'x12'2". The exterior is covered with roofing felt over wood siding. The main entry is on the east elevation, which includes a doorway with no door and a window opening with no window. The south elevation also has a window opening. A shed roof addition measuring 11'8"x 20'10" is located on the north side of the house. A

**Figure 77. The Remington/Duffy/Baquir House, 1993. The view is looking southwest.**

window opening is located on the east and north elevations. A shed roof addition is located on the west side of the house and measures 9'x12'. The shed roof is missing and the west wall is collapsed. Another addition measuring 12'1"x20' extends to the south from the west addition. The shed roof and east and west walls are missing. The west wall has collapsed. A door way, now missing, faced south.

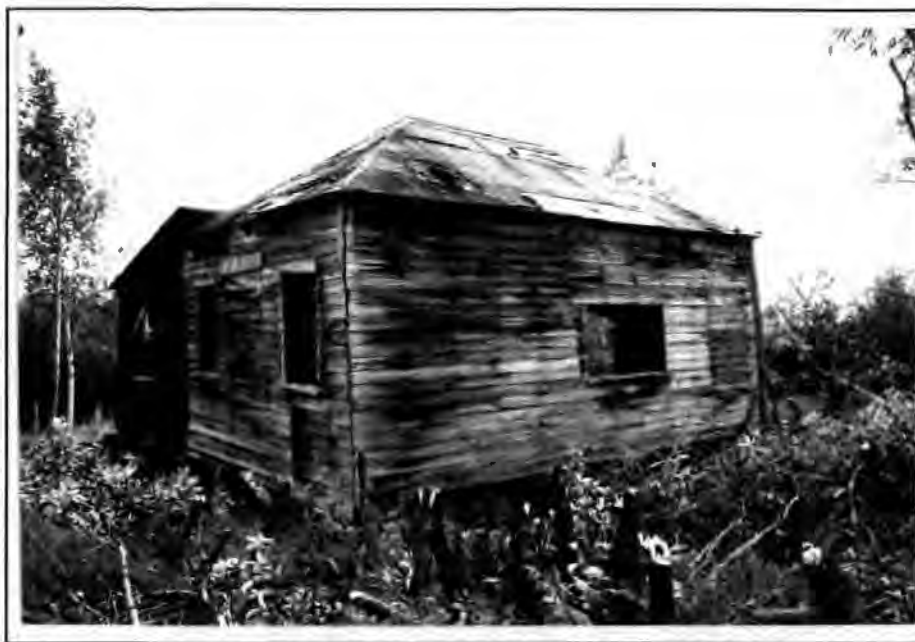
The **Harry Agoff House (IDT-135)** is a rectangular, one-story, wood frame building (Figure 78). The foundation is log and wood blocks on grade. Roofing felt covers the hipped roof. The building measures 15'10"x24'5". The exterior is covered with shiplap and features corner boards. The main entry is on the west elevation, which includes a decorative single-light, fixed sash window and a shed roof arctic entry. The roof of the arctic entry is covered with roofing felt and the exterior is covered with horizontal wood siding. The south wall of the arctic

entry is missing. A two-light, decorative fixed sash window is on the west elevation. The upper light is a band of diamond lights. The north elevation of the house has a window opening with no frame and another window that has been permanently boarded up. The east elevation has two window openings. One was formerly a door and a third window has been permanently boarded up.

A 14'11"x24'5" addition on the south side of the house rests on a wood block foundation. The shed roof is covered with roofing felt over wood decking. The exterior is sided with roofing felt over shiplap. A window opening is present on the east, west and south elevations. A door opening is located near the middle of the wall between the house and the addition. The building is in poor condition.

Figure 78. The Harry Agoff House, 1993.  
The view is looking northwest.

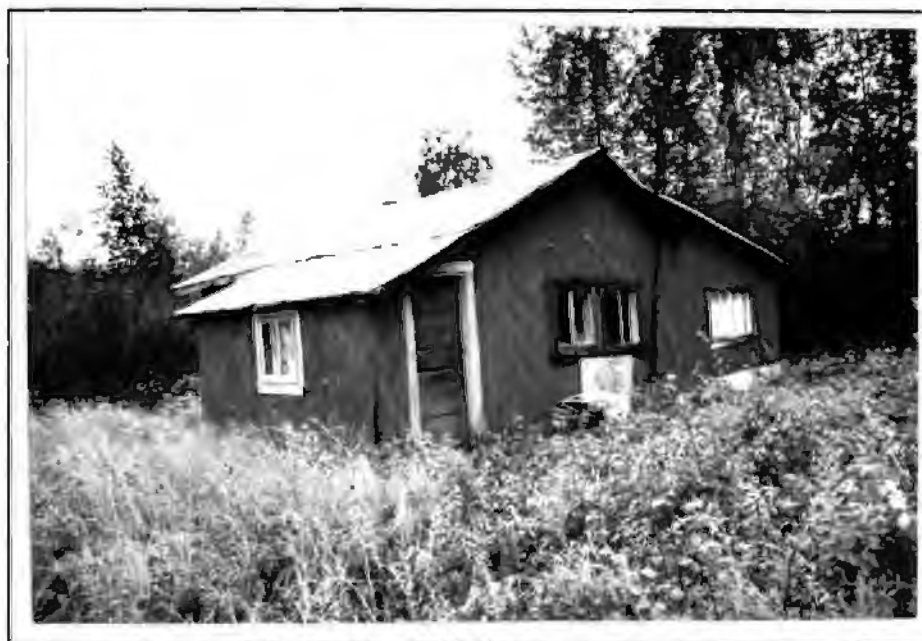
The **Ogriz House (IDT-132)** is a rectangular, one-story, wood frame, building with three additions (Figure 79). The foundation is not visible. Corrugated metal and roofing felt cover the gable roof. The house measures 14'2"x22'4" and the roof line is oriented north-south. The exterior walls are covered with roofing felt. The three additions have the same roof covering and exterior siding as the house. The main entry is on the west elevation, which includes a shed roof addition measuring 5'4"x12'4". This addition has a five-panel door facing south, a two-light, fixed sash window facing west and a four-light, fixed sash window facing north. The south elevation of the house has a pair of two-light, fixed sash windows. The north elevation has a two-light, fixed sash window and a boarded up window in the gable. A shed addition on

the east side of the building measures 12'x 22'4". A pair of two-light, fixed sash windows are located on the south elevation. A five-panel door and a two-light, fixed sash window are located on the north elevation. A two-light, fixed sash window and a shed addition measuring 7'2"x18'4" are located on the east elevation. This third addition has two six-light, fixed sash windows on the east elevation and a four-light, fixed sash window on the north elevation.

Figure 79. The Ogriz House, 1993.  
The view is looking northeast.

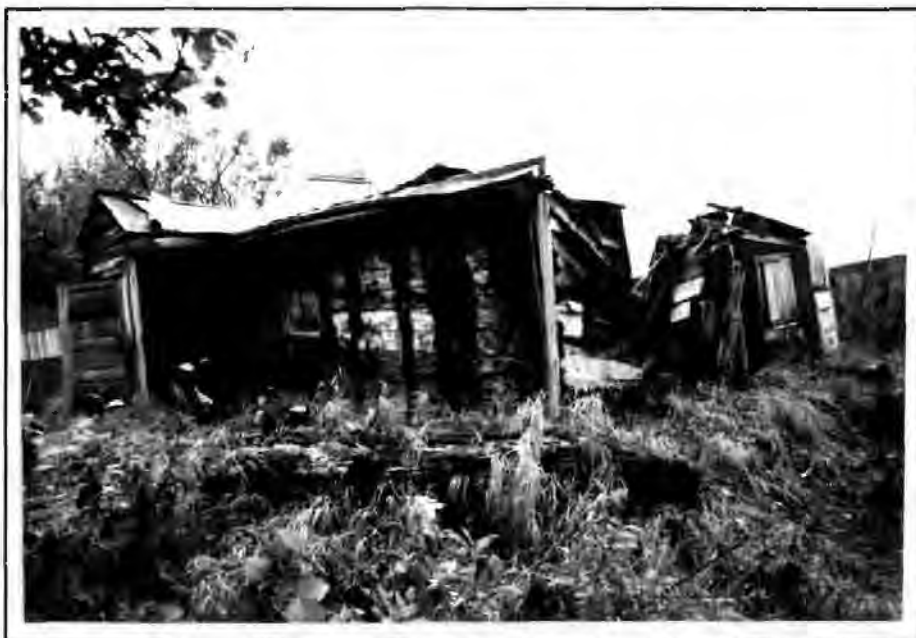
The Kardanoff/Hatten/Stuver House (IDT-131) consists of the ruins of a rectangular, one-story, wood frame building (Figure 80). The log foundation is on grade. The gable roof is covered with corrugated metal. The house measures 11'x21'8". Weathered roofing felt over wood siding covers the exterior walls. The east wall and roof on the east end of the house have collapsed. The main entry is on the south elevation, which includes a four-light, fixed sash window and a gable roofed arctic entry measuring 5'x6'. The arctic entry has a four-light, fixed sash window facing west and a door opening facing south. A five-panel door is leaning against the entry just outside the building. A window opening is centered in the east and west elevations

of the house. A 11'6"x20'4" shed addition is located on the north elevation. The roof, which was covered with roofing felt, has collapsed into the addition. A two-light, fixed sash window is located on the east elevation and a six-light, fixed sash window is on the ground below a window opening on the west elevation. An entry without a door and a boarded up window are located on the north elevation of the addition. Flooring on the ground just north of the addition suggests that another shed was attached to the north.

The ruins of a partially collapsed shed are located 7'4" west of the house. The shed roof is missing. The shed measured 12'6"x21'. Corrugated metal over wood siding covers the exterior walls. The corrugated metal is stripped in areas exposing the siding. Part of the east wall is missing and the other walls are warped. The south elevation contains a door opening and a two-light, fixed sash window. A

**Figure 80. The Kardanoff/Hatten/Stuver House, 1993. The view is looking northwest.**

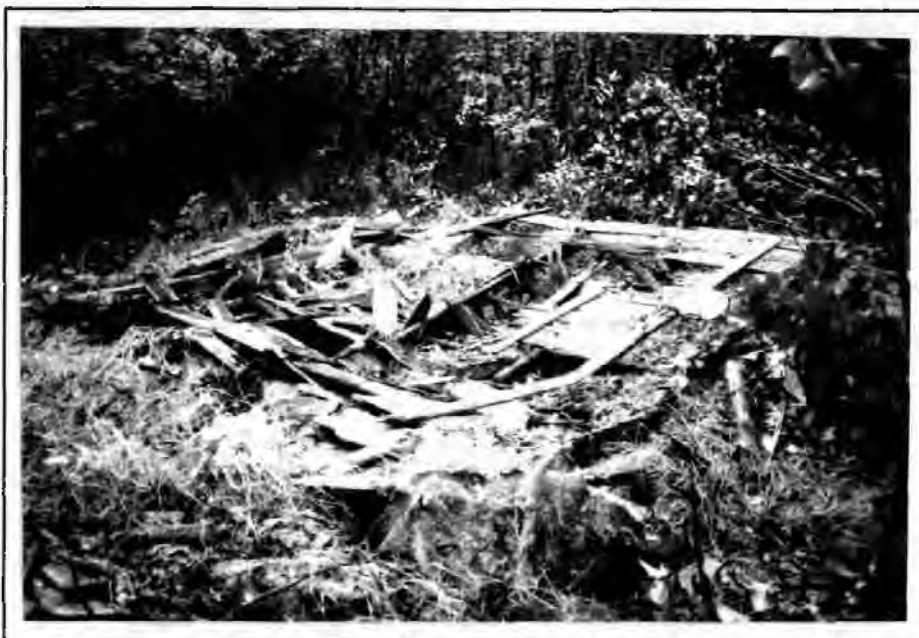
**The Anderson/Stuver House Ruins (IDT-136)** consists of the remains of a rectangular, one-story, wood frame building (Figure 81). The walls and roof are missing. The foundation is horizontal logs on grade. The building covered an area measuring 10'x15'4". The flooring consisted of 1"x2" lumber on 2"x4" joists. Small scraps of corrugated metal and linoleum are located around the building. Artifacts present at the site include small sections of cable, glass

**Figure 81. The Anderson/Stuver House Ruins, 1993. The view is looking northeast.**

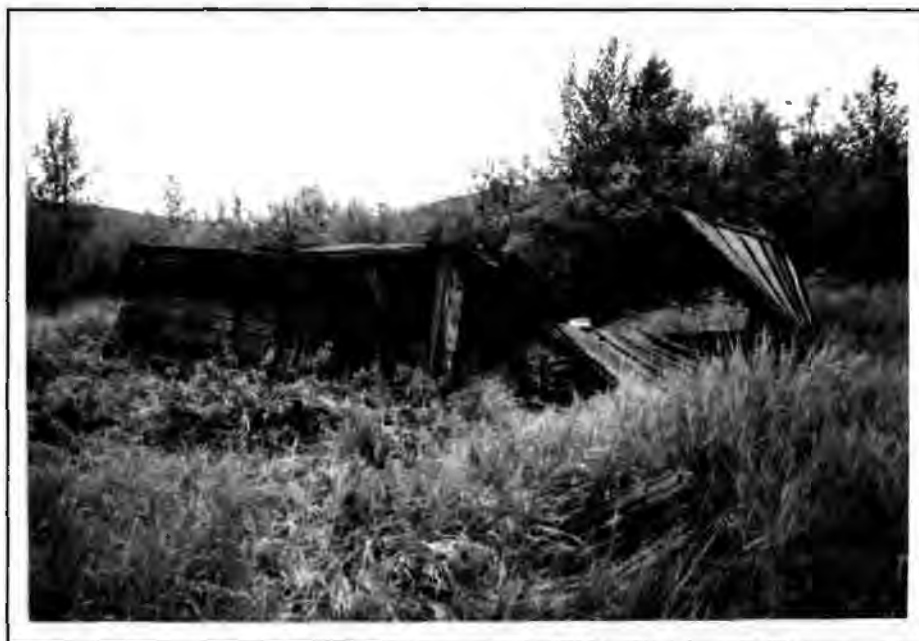
The **McConeghy/Balange House** (IDT-137) consists of the ruins of a square, one-story, log building (Figure 82). The foundation is horizontal log on grade and the building, which has collapsed, measures 15'5" per side. Roofing felt and corrugated metal cover the hip roof. The exterior is log. A partially collapsed shed addition is lo-

**Figure 82. The McConeghy/Balange House Site, 1993. The view is looking northeast.**

cated on the south side of the house. The addition measures 11'x15'5" and the exterior is covered with wood siding. The shed roof, which has partially collapsed into the structure, is covered with roofing felt. A plank door is located on the south elevation. Another addition is located on the east side of the south addition. The east addition, which has become separated from the rest of the house, measures 9'x11'. The addition has tipped over, with the shed roof facing east.

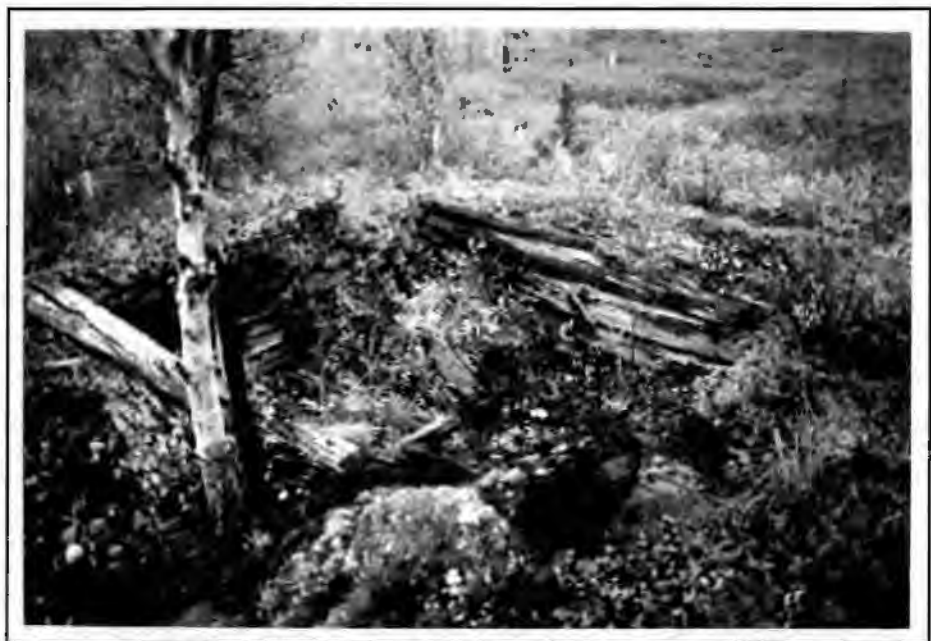
The remains of an **Underground Cold Storage Facility (IDT-244)** are located 78' west the McGoneghy house ruins (Figure 83). All that is visible of the cold storage facility on the surface is the entryway, which is caved in. The entry consists of a circular berm surrounding a rectangular log structure. The rectangular entryway measures 8'5" x 9'5" and is 4' deep. The roof is missing and the entryway is partly filled with earth and brush growing on top.

**Figure 83. The entry to the Underground Cold Storage Facility, 1993. The view is looking north.**

It is not known if the underground chamber is still in tact. About 50' west of the entry to the Underground Cold Storage Facility are the ruins of a collapsed frame shed. The roof and walls of the shed were covered with corrugated metal.

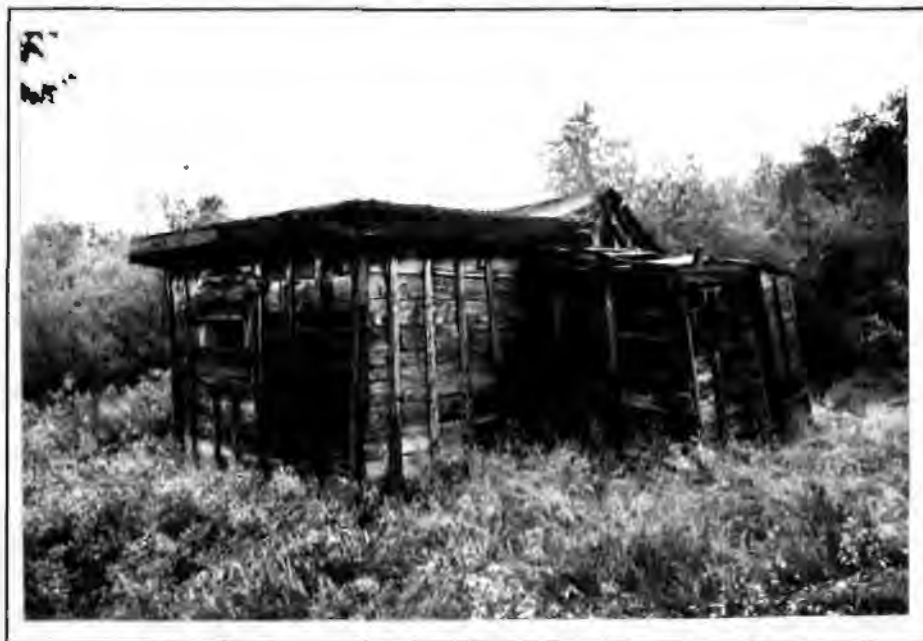
The **Bassoff/Sakow House (IDT-138)** is a rectangular, one-story, wood frame building (Figure 84). The foundation is log on grade. The building measures 7'x10'2". The gable roof is covered by roofing felt over wood decking, although most of the roofing felt has blown off. The east side of the gable roof is partially collapsed. The exterior walls are covered by deteriorated wood siding. A hoarded up window is located on the east elevation and a shed roof addition measuring 4'5"x8'2" covers the south elevation. The roof is covered with wood decking and has partially collapsed. The addition has a six-light, fixed sash window and a door opening facing south. A four-panel door is leaning against the wall just inside the entry. Another shed addition measuring 9'x10'2" is located on the west side of the

Figure 84. The Bassoff/Sakow House, 1993.  
The view is looking northeast.

building. A window opening is located on the north and west elevations of the addition. The building and its additions are in poor condition.

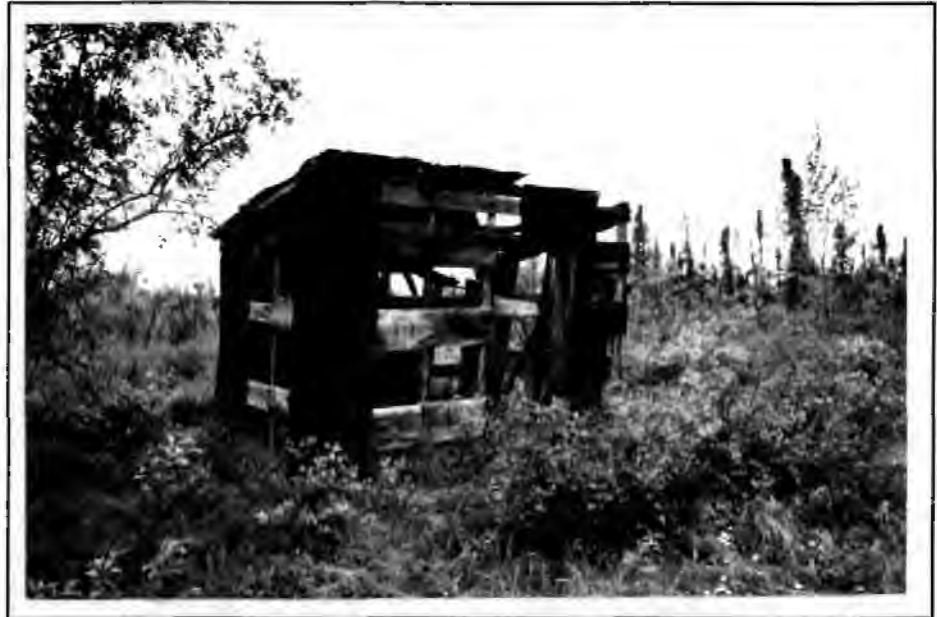
A rectangular pole and wood frame shed is located south and west of the Becker House ruins and 80' west of Flat Creek Road (Figure 85). The foundation is on grade. Corrugated metal covers the exterior walls. The building measures 7'2"x10'6". The shed roof is covered with corrugated metal, but the west half of the roof is missing. A screen mattress frame and an enamelware pitcher are located inside the building. A four-panel door is laying on the ground northwest of the building. A scatter of scrap metal, gas cans and barrels are located east of the building.

**Figure 85. Cap Becker's log and wood frame shed, 1993. The view is looking northeast.**

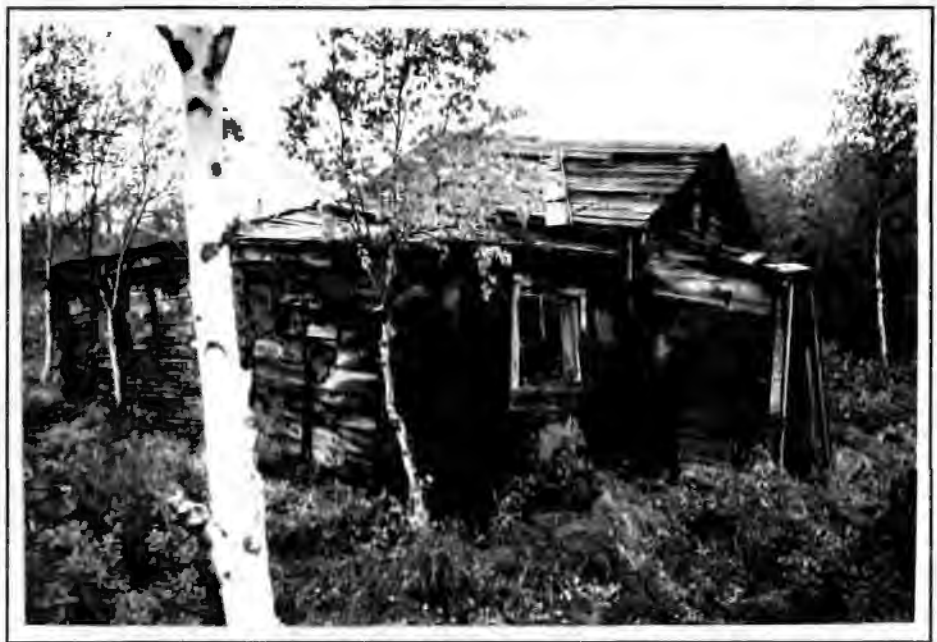
The **Crook/Caughrean/Demientieff House (IDT-140)** is a rectangular, one-story, log and wood frame building with five additions (Figure 86). The foundation consists of beams on grade. The gable roof and exterior siding is

covered with roofing felt over wood siding, although most of the roofing felt on the roof is missing. The house measures 12'x 15'. The main entry is on the east elevation, which includes a window opening and a 4'x5'10" shed roof arctic entry. The arctic entry has a doorway facing east. A shed addition on the south side of the house measures 7'7" x12'. Unlike the roof of the house and other additions, the roof addition is covered with corrugated metal. A single-light, fixed sash window faces east and a small boarded up window faces south. Another shed addition is located on the west end of this addition and measures 7'7"x 12'. A window opening faces south. Another shed addition is located on the west end of the house. This

**Figure 86. The Crook/Caughrean/Demientieff House, 1993. The view is looking northwest.**

addition measures 7'x11'10". The west wall is made of logs and has a window opening. A shed addition on the north side of the building measures 10'6"x14'7". A window opening is located on the north and east elevations. At the west end of this addition is another shed roof addition measuring 10'5"x10'6". A doorway faces north, and most of the wood siding has been removed from the north, west and south walls. The house is in poor condition.

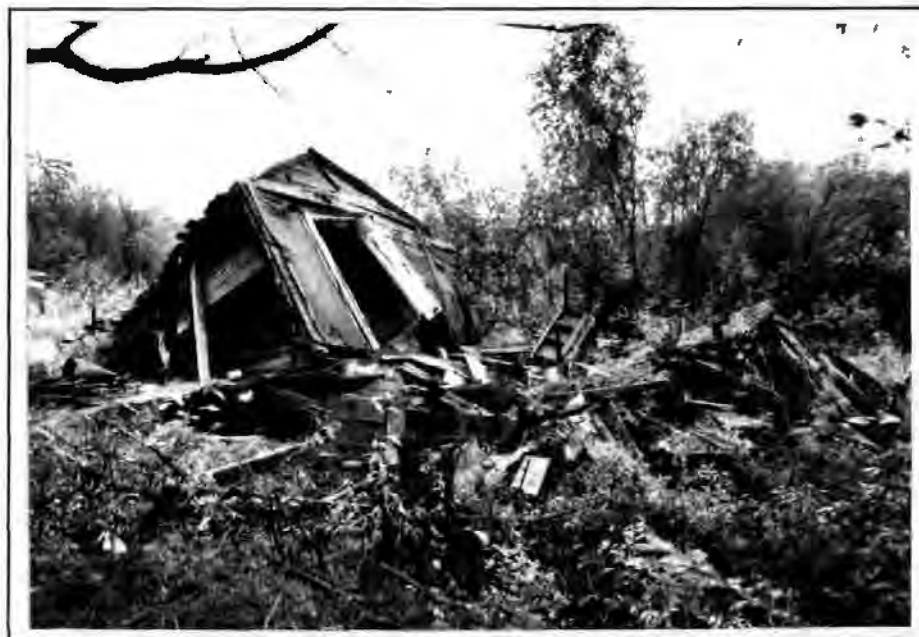
The Nash/Miller House Ruins (IDT-141) consist of a collapsed rectangular, one-story, wood frame building (Figure 87). The foundation is log on grade. Weather torn roofing felt over wood decking covers the gable roof and exterior walls. The building measures 12'4"x 12'10". The house collapsed toward the west elevation, which had a centered doorway. Only the roof and east elevation have nominal structural integrity. The east elevation had a door opening and a boarded

up window. The ruins of an addition are located on the east side of the building. The shed roof and exterior were covered with roofing felt over wood decking. The addition measured 10'10"x 19'3". The north and south walls and part of the east wall of the addition lay outside the foundation. Artifacts include box springs, a wood stove, two wooden trunks, a table, bottles, jars, eating utensils, baby toys and other domestic items.

Figure 87. The Nash/Miller House, 1993.  
The view is looking northwest.

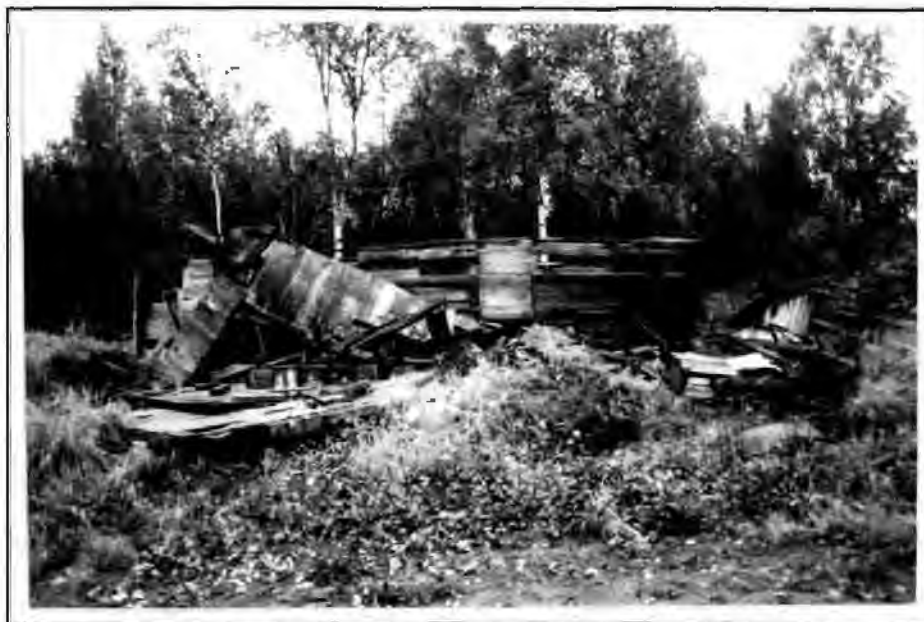
The **Guggenheim Machine Shop (IDT-143)** consists of the ruins of a large, rectangular, one-story, wood frame and log warehouse building (Figure 88). The foundation is on grade. The gable roof, which has collapsed, was covered with corrugated metal. The outline of the building measures 23'x47'. The exterior was covered with wood siding. Most of the west wall is standing. The other walls have collapsed. A 6/6 single-hung window, two boarded up windows, and a boarded up door are located in the west elevation. Portions of the north elevation, including a section of wall and part of the gable, are laying on the ground. The wall section contains a plank door. Another section of the north wall contains log framing. A portion of the west end of the south elevation is still standing and contains a plank door. Another section of the west wall containing a plank door is laying in the ruins. A shed roof addition was attached to the south end of the warehouse. The addition measured 14'x23'. A portion of the addition's west elevation is standing and contains a boarded up window. Another section of the west elevation has collapsed and contains a partial window opening. The south and east walls of the addition are collapsed.

The building ruins include structural debris such as timbers, wood siding, small sections of the roof, and pieces of corrugated metal. Many of the timbers and some of the siding from collapsed portions of the building have been salvaged. There are also a large number of artifacts in the ruins which include crates and bins filled with machine parts and metal barrels. Domestic items, such as pans and dishes, are located among the ruins of the south addition.

**Figure 88. The Guggenheim Machine Shop, 1993. The view is looking west.**

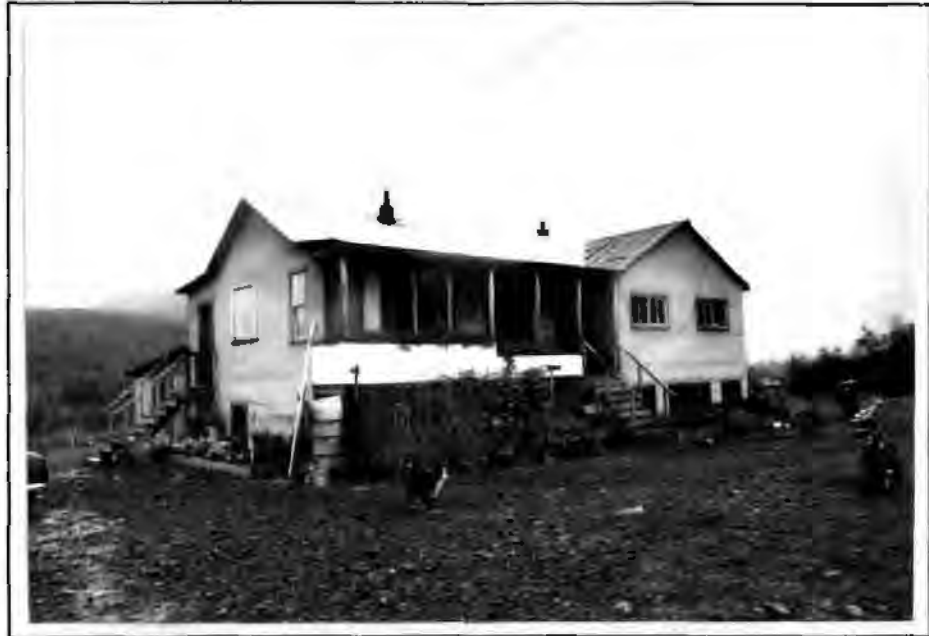
The **Kepler House (IDT-123)** is a modified rectangular, one-story, wood frame building with a day-light basement (Figure 90). This structure consists of two buildings which have been combined to create a single residence. The foundation is treated timbers on grade. Corrugated metal covers the gable roof and grey roofing felt covers the exterior walls. The main section of the house (the old Matheson Bunkhouse) measures 20'x26'2" and the gable roof is oriented north-south. The south elevation has two 2/2 horizontal single-hung windows on the main floor and a pair of six-light, fixed sash and two six-light, fixed sash windows on the basement level. The east elevation has a triple 4/4 horizontal double-hung window and a 2/2 horizontal single-hung window on the main floor and pair of side opening plank doors flanked on each side by a nine-light, fixed sash window. The north elevation has a 2/2 horizontal single-hung window and a six-light, fixed sash window on the main floor and two six-light, fixed sash windows on the basement level.

A gable roof addition (the old NADC Steam Bath) on the west side of the house measures 18'2"x26' and is oriented east-west. The south elevation has a one-panel door with one light, a two-light, fixed sash window, and bay window with four 4/4 single-hung windows on the main

floor. A 4' wide porch with a shed roof runs the length of the south elevation. The main floor of the west elevation has a 4/4 single-hung window and a decorative two-light window in which the upper light has a row of diamond lights. A six-light, fixed sash window is located on the basement level. A 4' wide shed roof addition runs the length of the west addition. A one-panel door with one light faces west and a six-light, fixed sash window faces

**Figure 90. The Kepler House, 1993.**  
The view is looking northeast.

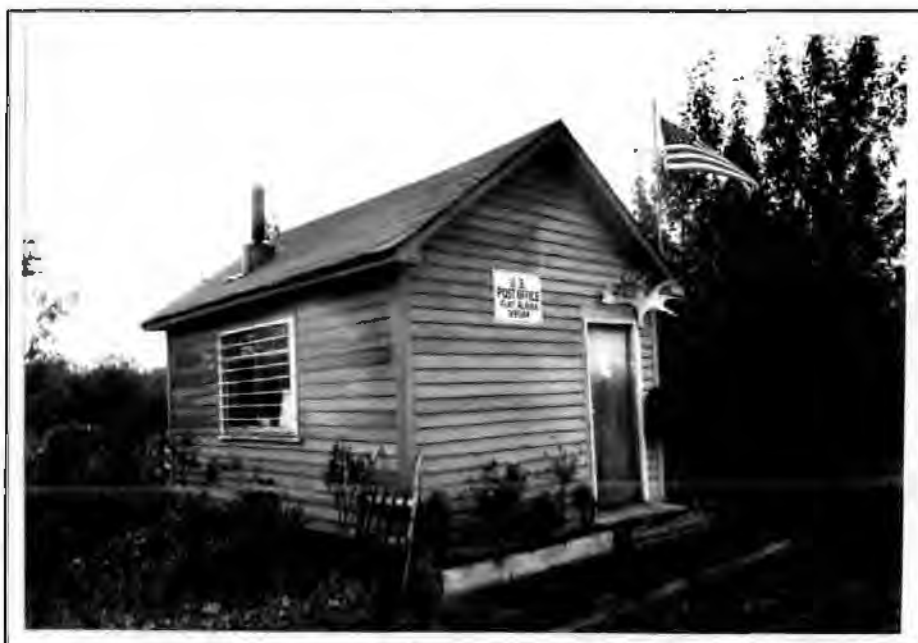
The NADC Office/Flat Post Office (IDT-124) is a rectangular, one-story, wood frame building (Figure 91). The foundation consists of logs on grade. Roofing felt covers the gable roof. The exterior is sided with clapboard and corner boards. The building measures 11'6"x15'8". The main entry faces east and has a slab door. A six-light, fixed sash window covered with metal bars is centered on the north and south elevations. The building has enclosed cornices.

Figure 91. The Post Office Building, 1993. The view is looking northwest.

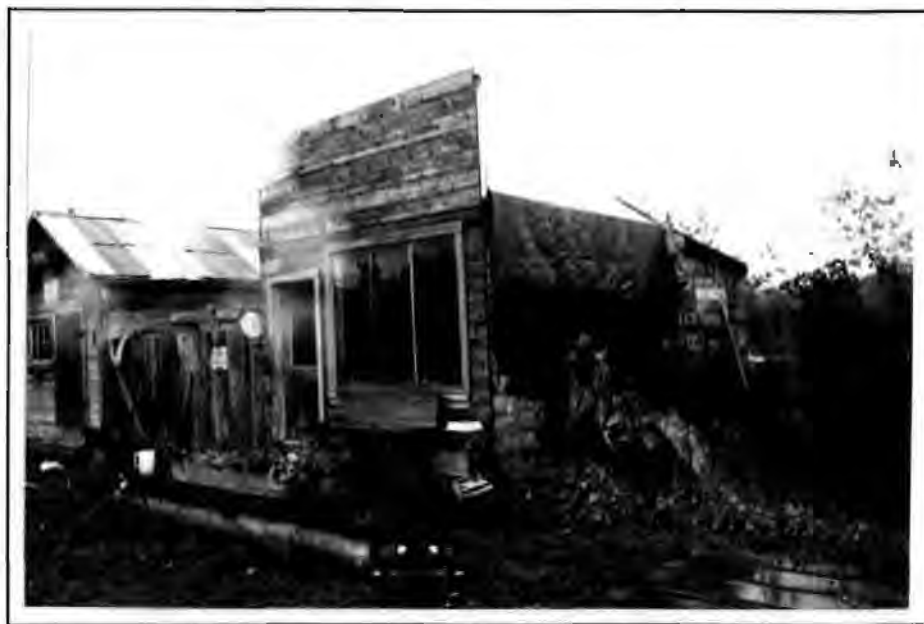
The Kepler Library/Darkroom (IDT-125) is a rectangular, one-story, wood frame, false front building (Figure 92). The foundation is wood beams on grade. Plastic tarp over roofing felt covers the gable roof. The building measures 11'6"x12'3". The exterior is covered with shiplap. The main entry is on the east elevation, which includes a two-panel door with eight lights and a large three-light, fixed sash store front window. A shed roof addition measuring 8'10"x11'6" is located on the west side of the building. The roof is covered with roofing felt. The exterior is covered with horizontal wood siding on the north and south sides and plywood on the west side.

**Figure 92. The Kepler Library/Darkroom, 1993. The view is looking southwest.**

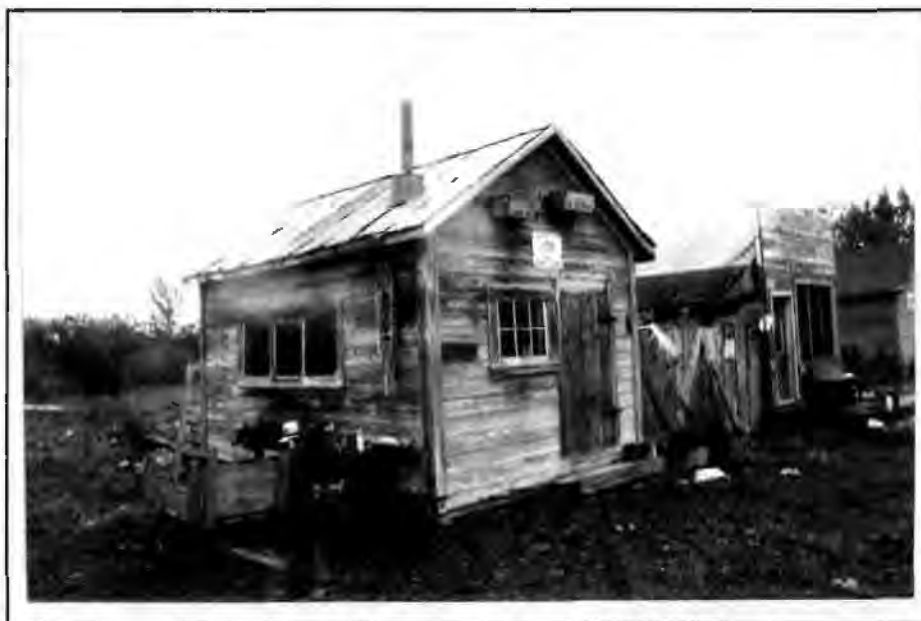
**The Burns/Kepler Workshop** (IDT-126) is a rectangular, one-story, wood frame, building (Figure 93). The foundation is wood blocks on grade. Corrugated metal and roofing felt cover the gable roof. The building measures 12'3" x 16'3". The exterior walls are covered with shiplap with corner boards. The main entry is on the east elevation, which has a plank door and a six-light, fixed sash window. The south elevation has a three-light, fixed sash window.

**Figure 93. The Burns/Kepler Workshop, 1993. The view is looking southwest.**
